**HYUNDAI**  
**Technical Service Bulletin**

<b>GROUP</b> <b>RECALL</b>	<b>NUMBER</b> <b>18-01-007-1</b>
<b>DATE</b> <b>JUNE, 2018</b>	<b>MODEL(S)</b> <b>2013-2014MY SONATA (YF) SANTA FE SPORT (AN)</b>

**SUBJECT:** SONATA / SANTA FE SPORT GDI ENGINE INSPECTION  
 / REPLACEMENT (RECALL CAMPAIGN 162)

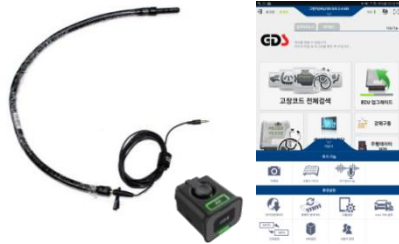
Description	Tool Part #	Image	Comment
Engine Noise Inspection Tool	G1XTD-CP005

For noise inspection
Torque Wrench Socket	09314-3Q100		Only needed if engine replacement required.
Injector Combustion Seal Ring Installer	09353-2B000		Refer to TSB 10-FL-019 for the detailed usage instructions

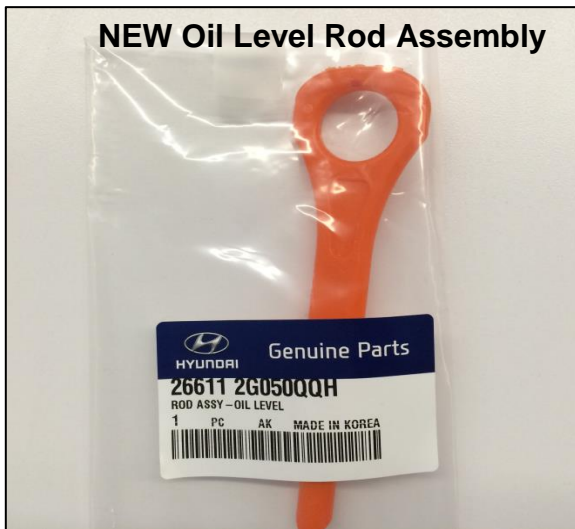
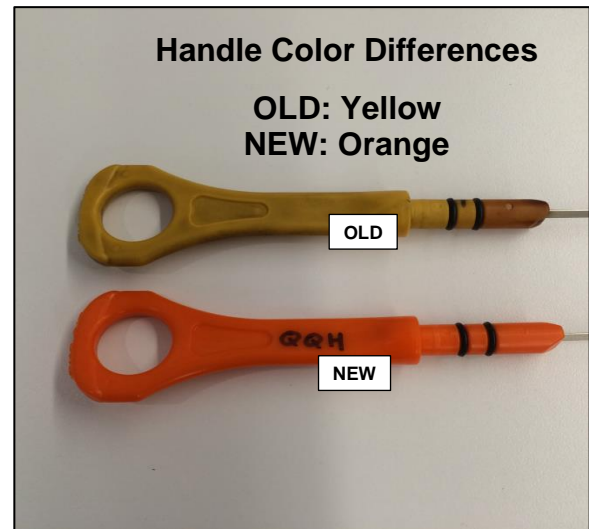
2. Replace the engine oil (4.8 quarts), oil filter, and drain plug gasket.
3. Replace the current Oil Level Rod Assembly with the new campaign part.
  - Remove and discard the existing Oil Level Rod Assembly (engine oil dipstick).
  - Install new ORANGE handle Oil Level Rod Assembly (P/N 26611-2G050QQH)

**Note: Replace the dipstick ONLY if the current dipstick's handle is yellow. Do not replace if it's red.**

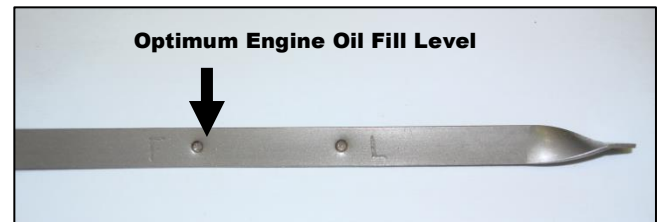
4. Start the engine and allow it to run for 10 seconds. Turn off the engine and after a few minutes adjust the engine oil level to near the "F" mark as shown in the picture.
  - Use Quaker State 5W-30 viscosity engine oil or other brand if not available (conventional type with API SM / ILSAC GF-4 or higher grade).
  - Do not overfill.

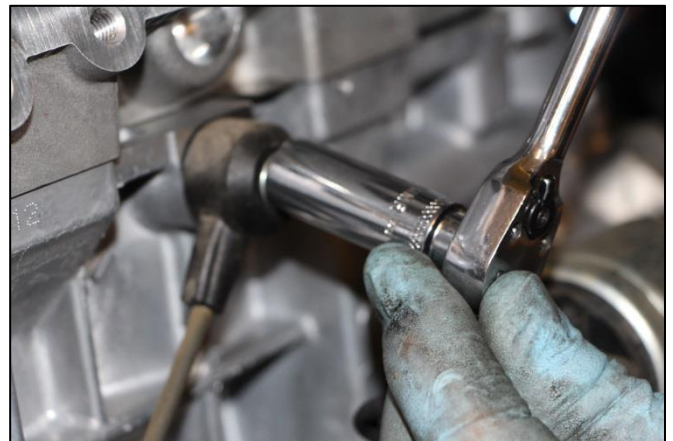
5. Remove and reinstall the engine Knock Sensor from the old engine to the new engine.

**(Knock Sensor Fastener)**  
**Tightening torque: 21Nm (15.5lb-ft)**

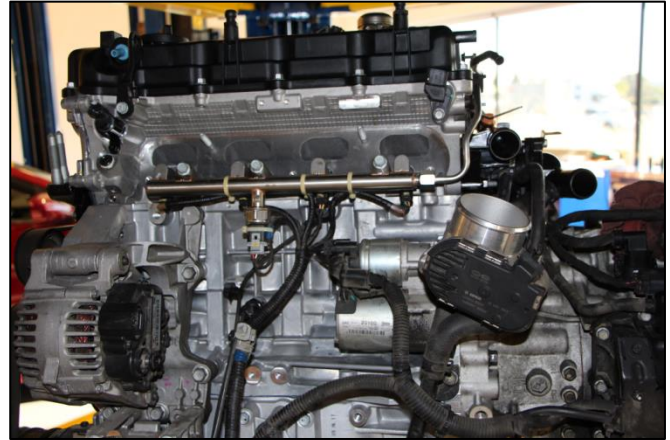
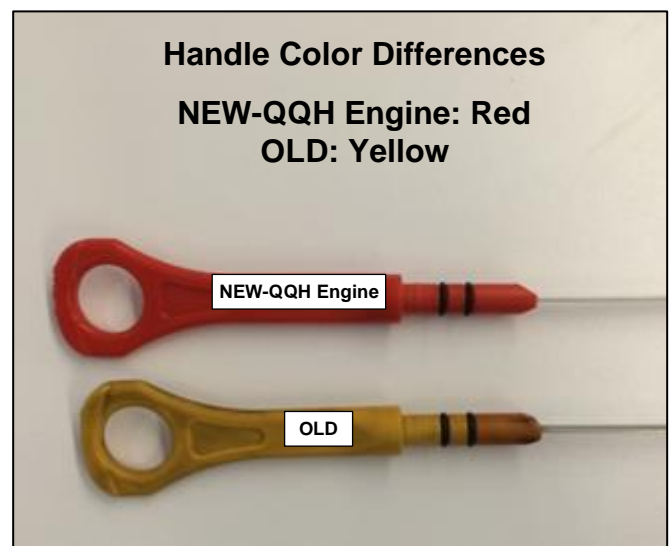
7. Install the new oil cooler hoses.
8. Reconnect and reinstall the engine front harness as shown.
  - Be sure to properly route the opposite end of the harness end down towards the front of the engine.
9. Install newly supplied Oil Level Guide and Oil Level Rod Assemblies to the new engine.
  - Be sure to install the NEW Oil Level Guide (dipstick tube) to the NEW engine.
  - Install the NEW Oil Level Rod Assembly (dipstick) to the NEW engine.

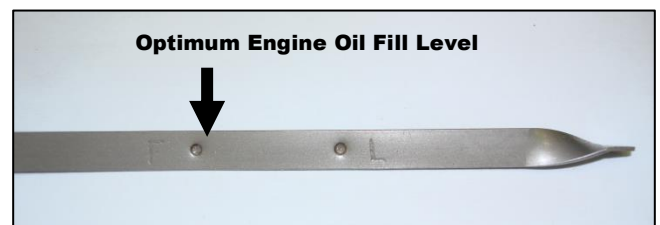
13. Start the engine to warm it up and begin the cooling system air bleeding process.
- During this time, check for any leaks.
  - After the engine has warmed up to normal operating temperature, turn the engine off, wait a few minutes, and then adjust the engine oil level to near the "F" mark as shown in the picture.
